# Manhole Inspection Summary

Manhole # S03CC2009MH

Insp Date: **7/14/06 9:55 AM**

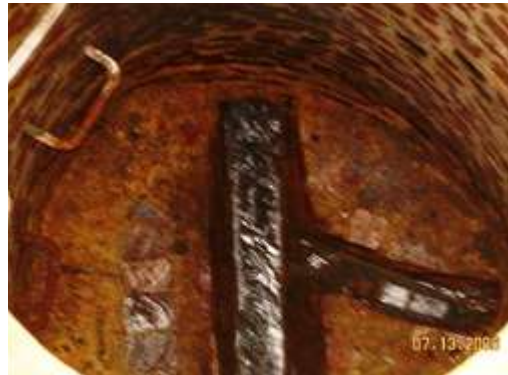
Top View

Corroded steps. Bench debris.

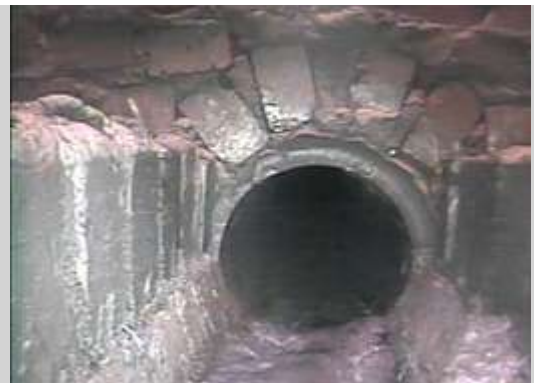
Pipe Out @ 12 O'Clock

Comments **The O12 pipe picture shows Barrel deterioration. The I3 pipe picture shows Channel deterioration. The I3 pipe seal is not flush to the pipe. There is an offset joint inside.**

Infiltration: **Evidence** Pipe Seal Cond: **Unknown**

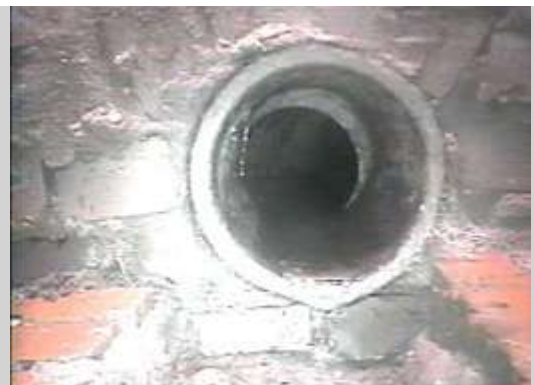
Pipe In @ 3 O'Clock

Infiltration: **Evidence** Pipe Seal Cond: **Unknown**

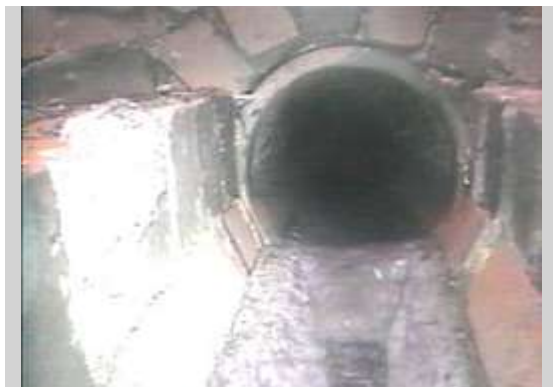
Pipe In @ 6 O'Clock

Infiltration: **Evidence**

Pipe Seal Cond: **Cracked**
